Date: 21/3/16
Time: 4:00:38 p.m.
File name: 2016_ITR_RP_detail.vwx

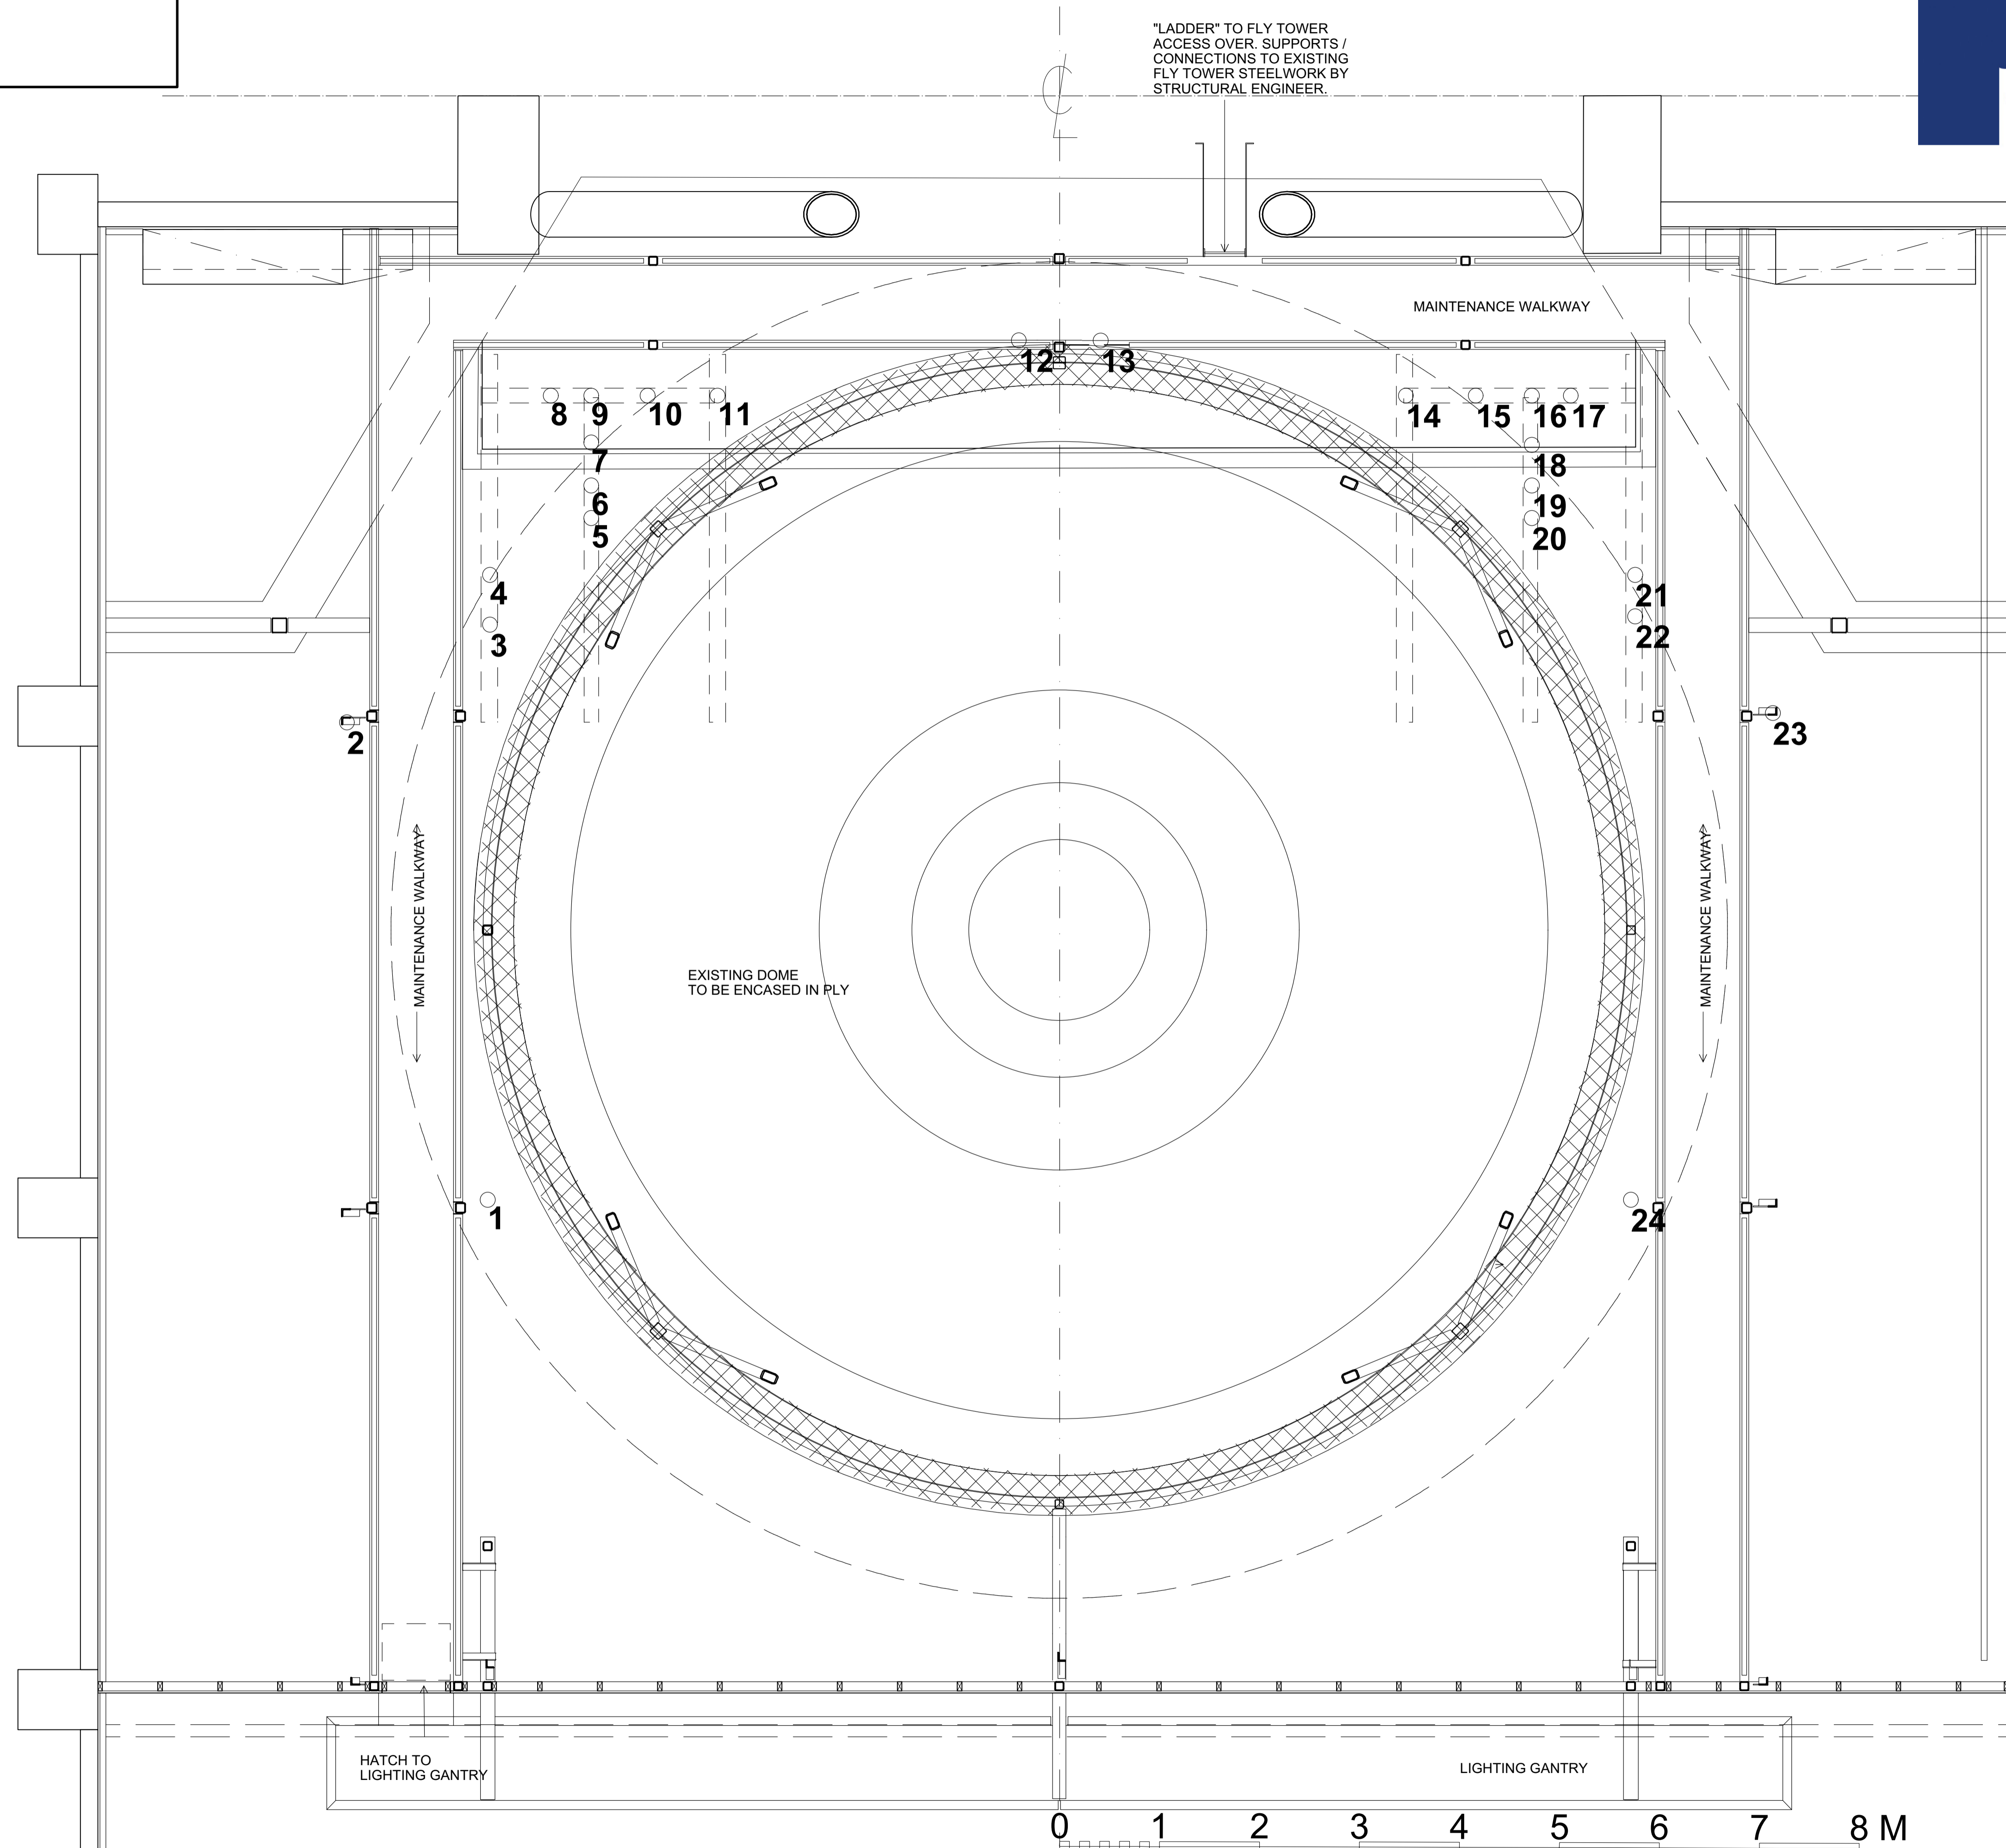
15.310m from beam to stage floor

7.210m from beam to underside of Proscenium Arch

8.100m from under side of Arch to Stage floor`

A Safe Working Load of 2000kg appeals to all rigging points
